by Paula Golightly

# Lower Cañon Creek Restoration

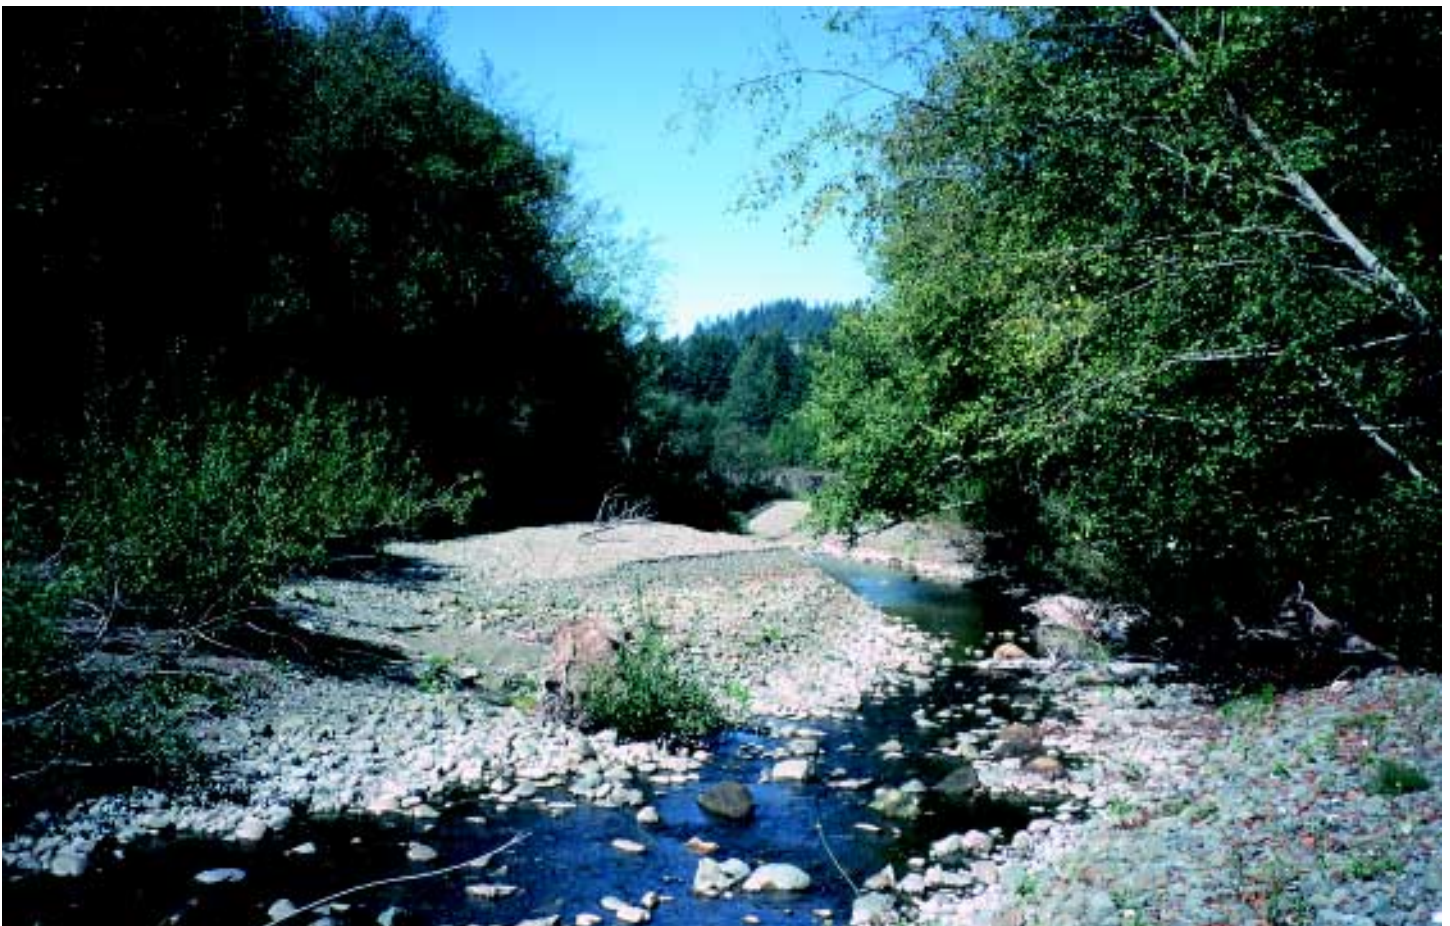
***Cañon Creek, looking downstream after the first winter since project implementation. The channel has begun to deepen and willows are growing on the left bank.***

After two winters, Cañon Creek has downcut approximately 3 feet (1 m) and has a deeper, more defined channel. Between 1997 and 1998, a small landslide released two redwood trees from the bank into the channel. The water flow has scoured deep pools

underneath the trees, creating excellent cover habitat for fish. Using a procedure called Photopoint Monitoring, a series of photographs were taken at exact locations periodically to assess project effectiveness. Photopoint and cross section monitoring will continue.
